TECHNICAL REPORT M10

**SEDIMENTATION AND NAVIGATION STUDY OF THE
MISSOURI RIVER,
COPELAND BEND
MILES 569 TO 564.5**

HYDRAULIC MICRO MODEL INVESTIGATION

Final Report - September, 1999

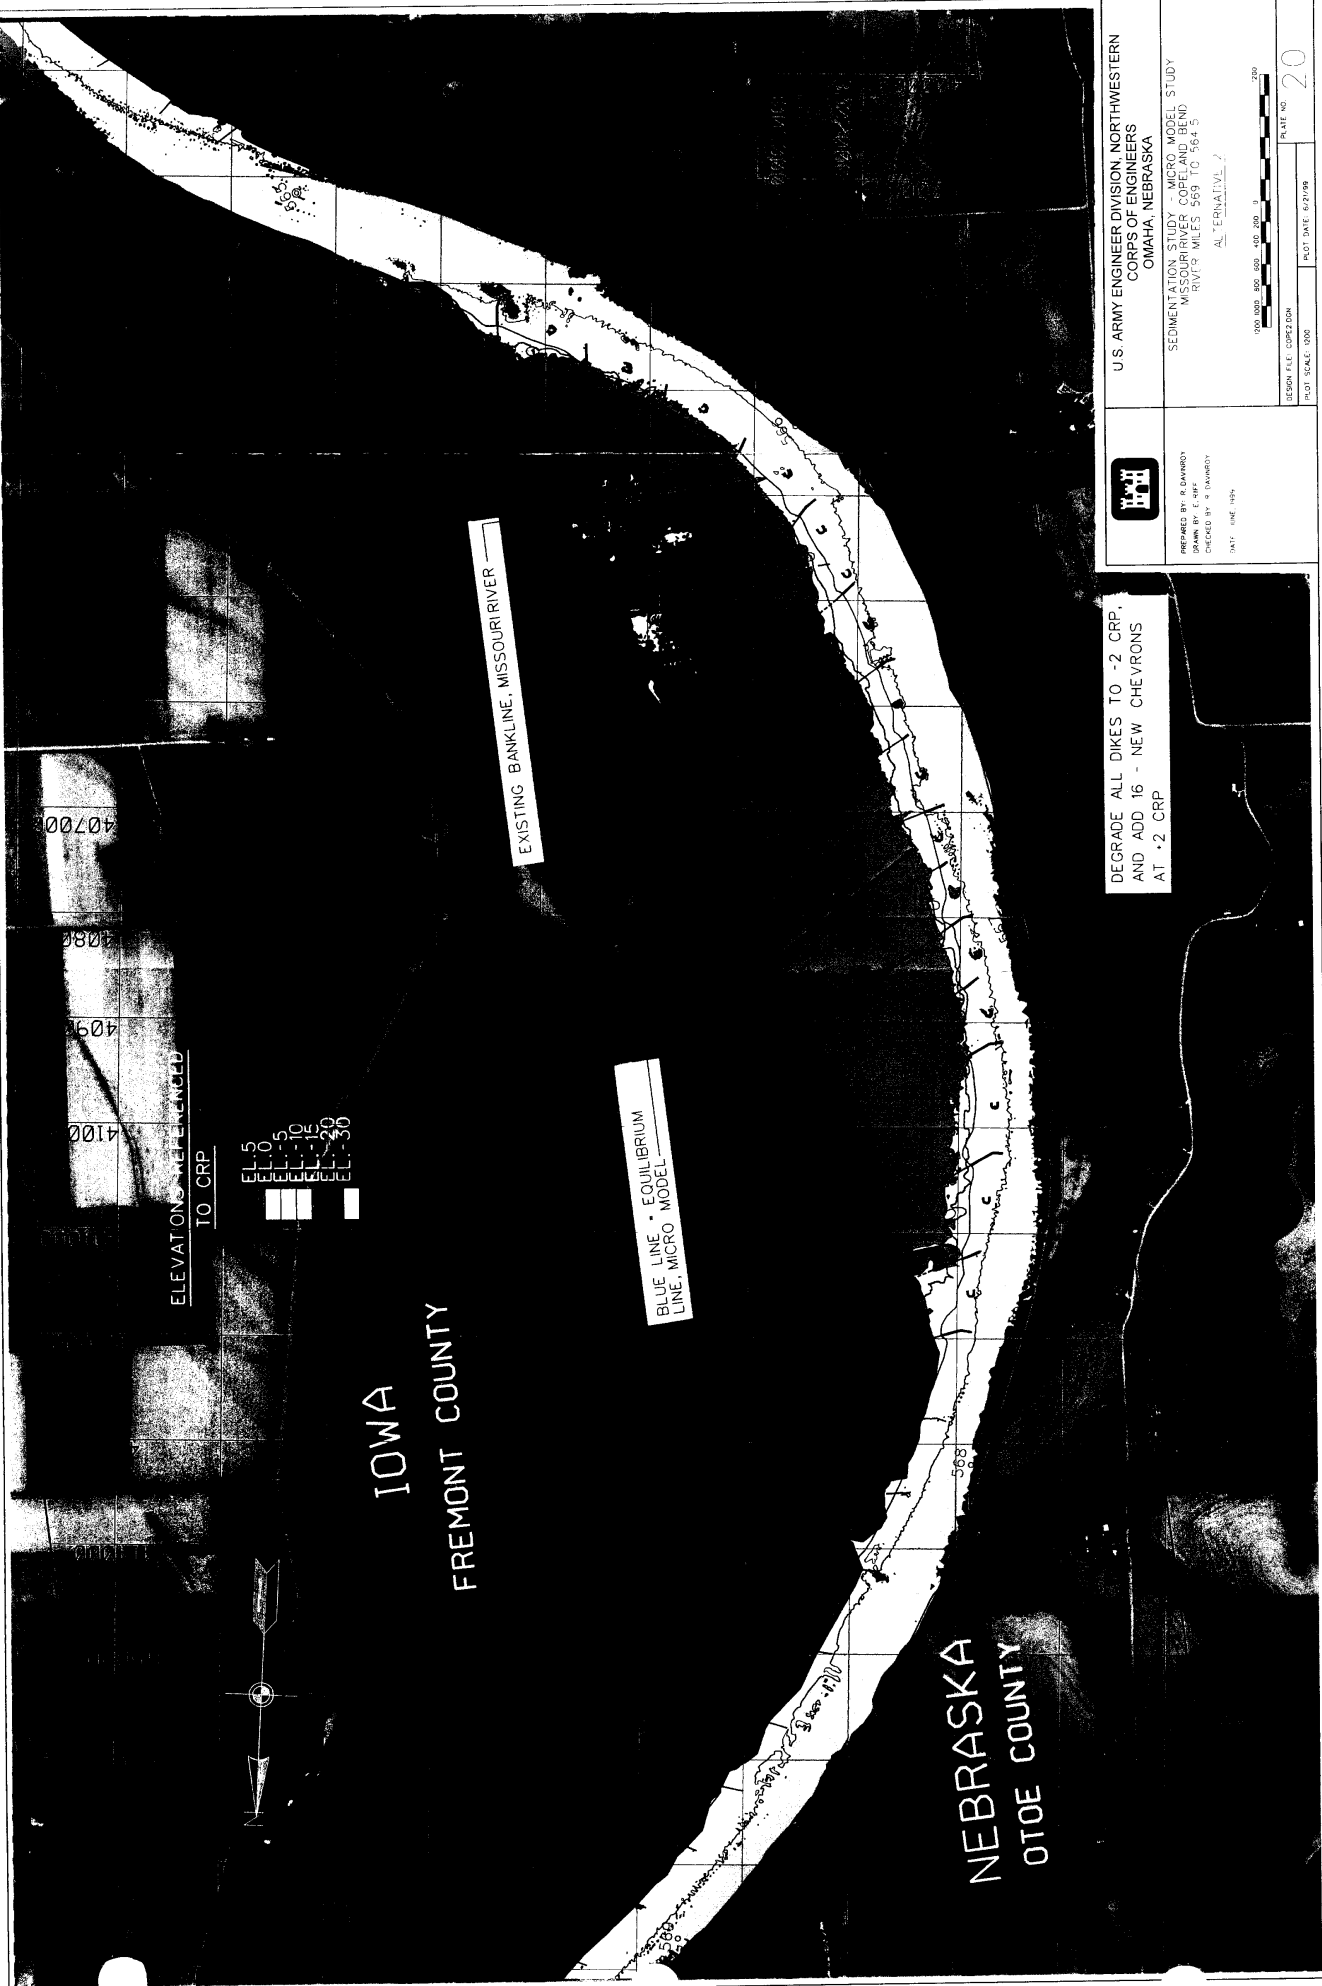
PLANT NO. 20

Alternative 2. Degrade All Dikes To -2 CRP and Add 16 New Chevrons At +2 CRP. Alternative 2 involved the degradation of all dikes to -2 CRP as in Alternative 1 and the addition of 16 new chevrons. The chevron crown elevations were placed in the model at +2 CRP. The chevrons were of the blunt-nosed type. Each deflection leg was 75 feet in length at a centerline deflection angle of 30 degrees. Radius of the blunt nose was approximately 25 feet. The chevrons were strategically placed in the middle of each dike spacing, except between dikes 612.0 and 611.85, where the structures were placed closer to the existing dikes. The chevrons were streamlined just within the dike endpoints for the purposes of generating maximum effects to the navigation channel. The goal was to place the structures as close to the main channel as possible but still

DEGRADE ALL DIKES TO -2 CRP,
AND ADD 16 - NEW CHEVRONS
AT +2 CRP

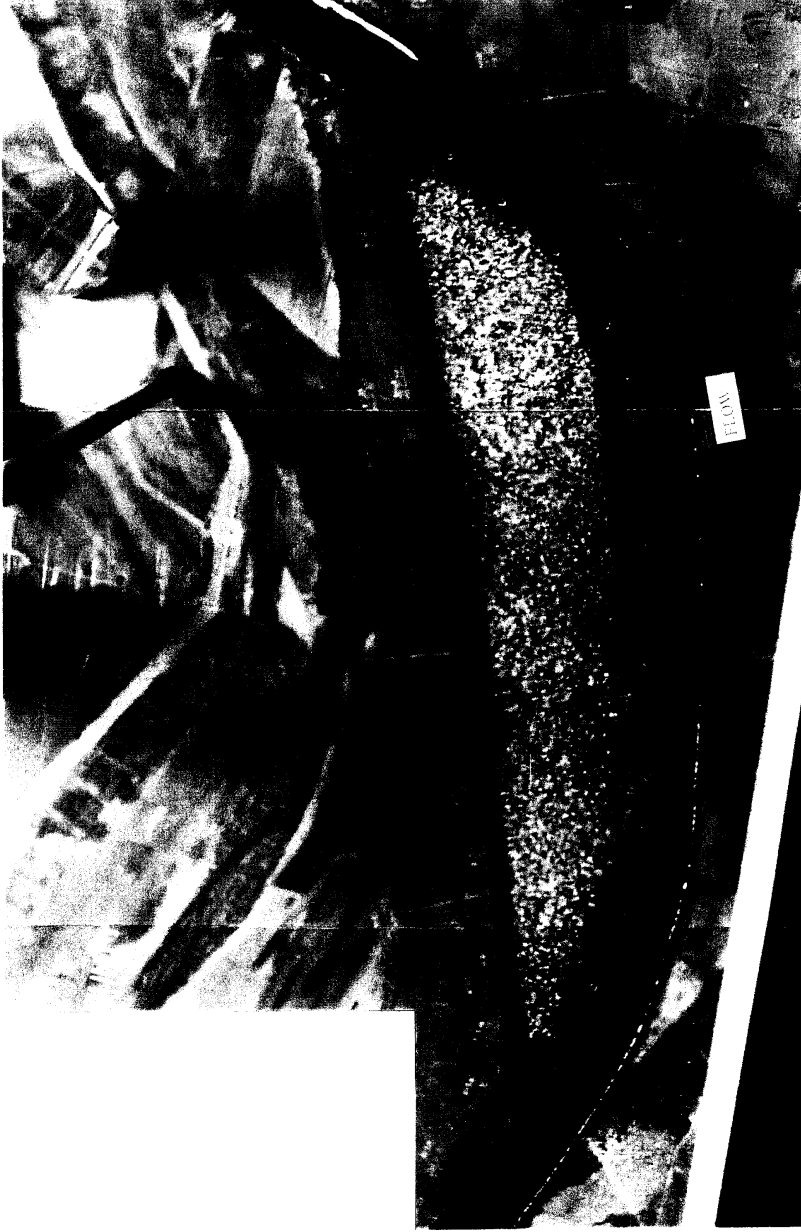
U.S. ARMY ENGINEER DIVISION, NORTHWESTERN CORPS OF ENGINEERS OMAHA, NEBRASKA
PREPARED BY: J. Gentry CHECKED BY: D. Gordon DATE: FEBRUARY 1991	Sedimentation Study, Missouri River Copeiland Bend, Flow Visualization Alternative 2 Degrade All Dikes to -2 CRP, Chevrons at +2 CRP
PLATE NO. 22

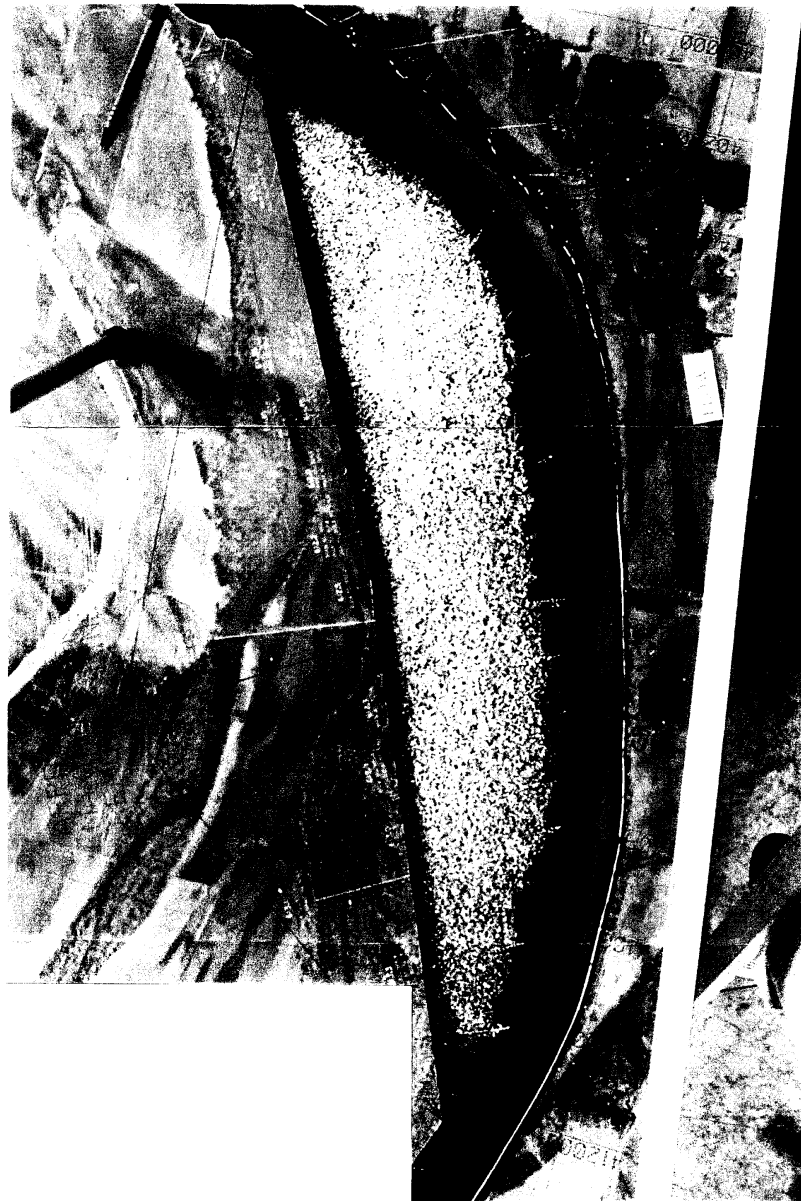
25

Alternative 3. Degrade Alternating Dikes To -2 CRP. Alternative 3 involved the degradation of alternating dikes along the left descending bank. Results (Plates 23, 24, 25) indicated the following trends:

Degrade Alternating Dikes to -2 CRP

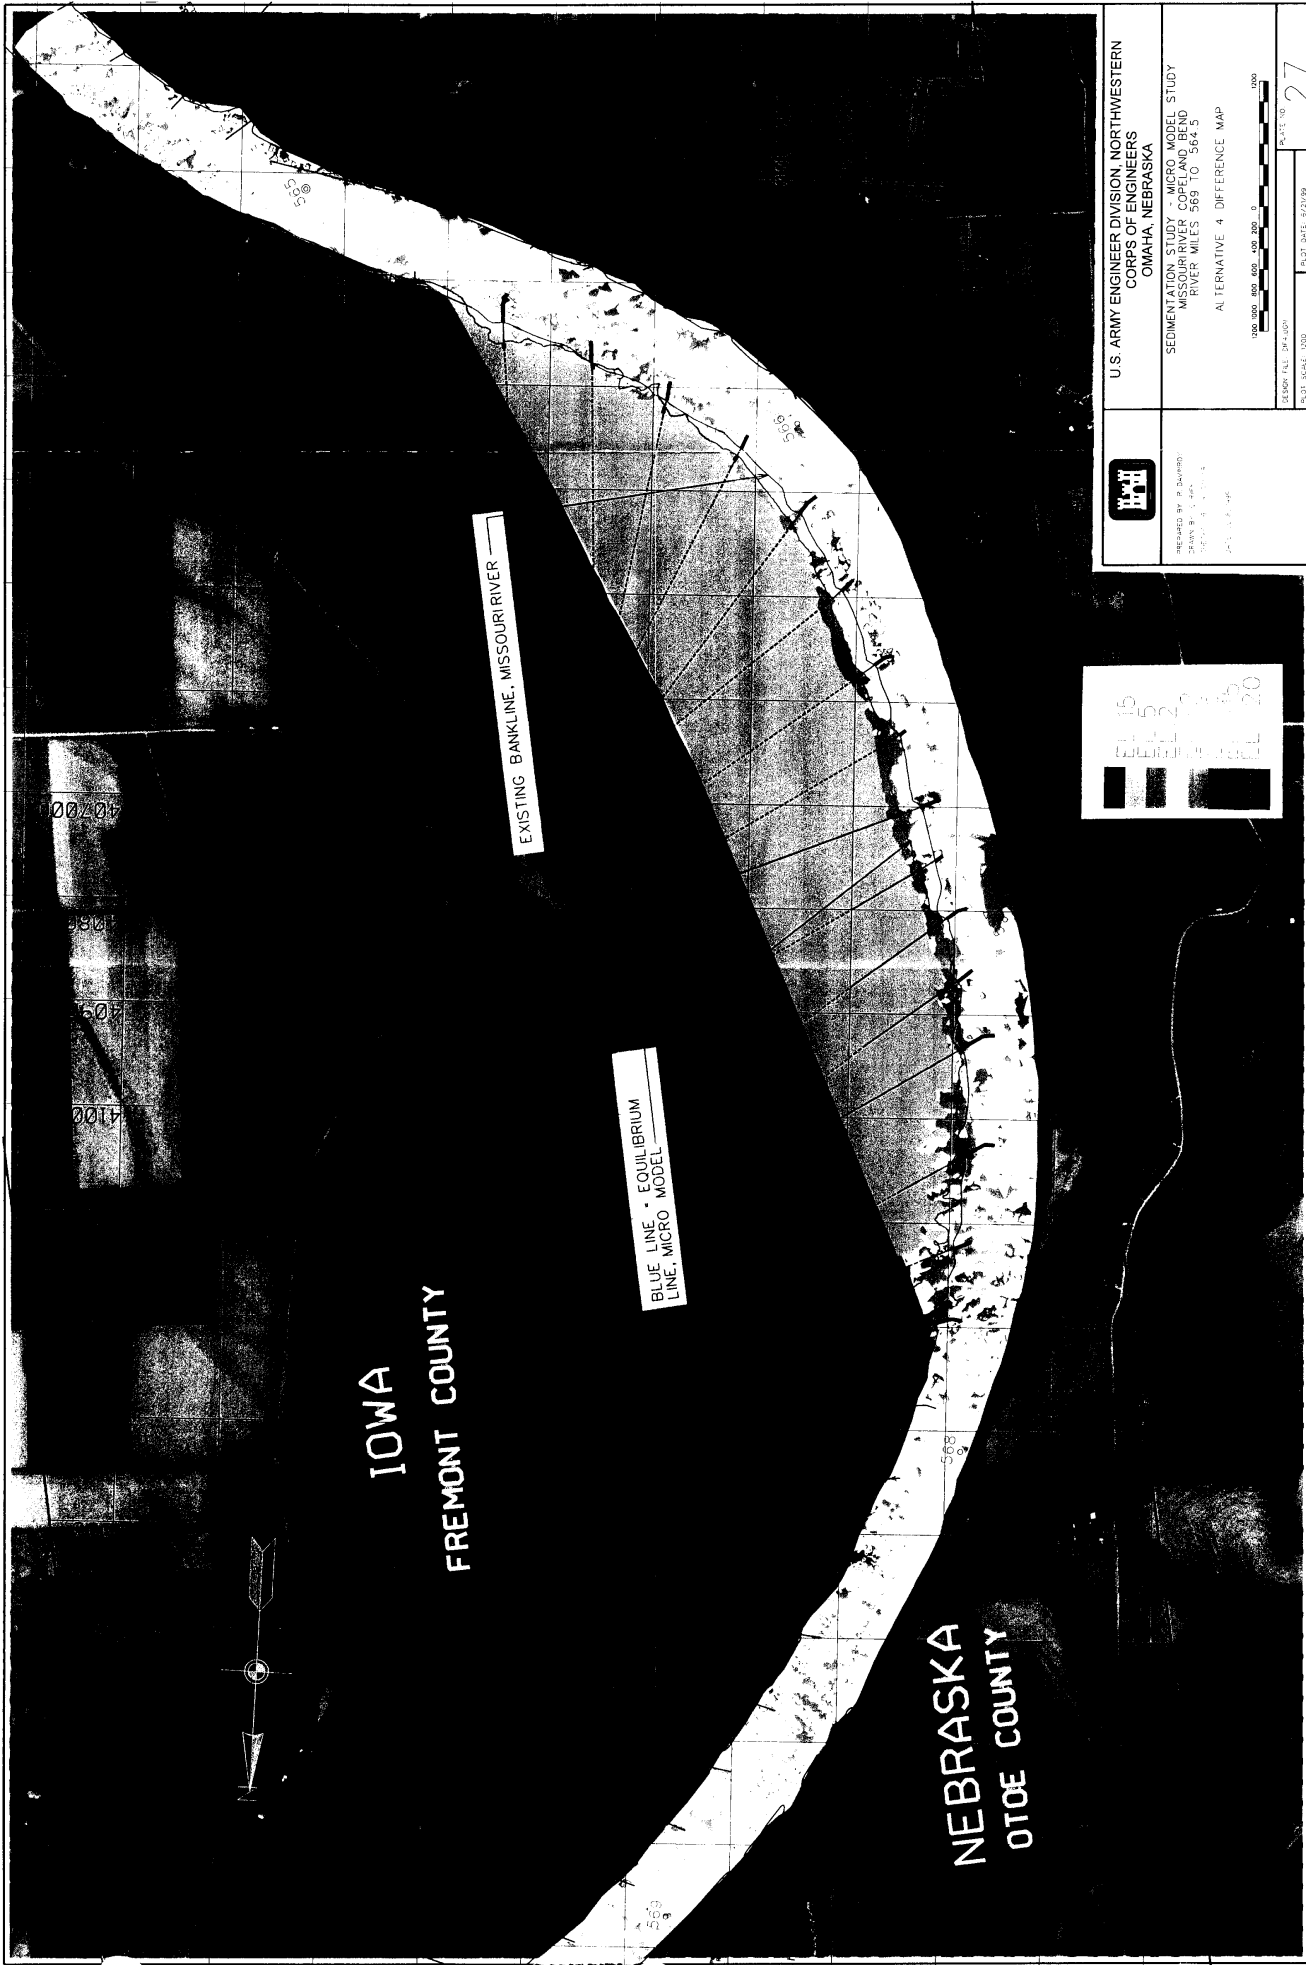
1000 800 600 400 200 0
1:25,000 (NAD 83) 1:25,000 (NAD 83)
SHEET NO. 27
SHEET DATE 12/2/99

Alternative 4. Degrade Alternating Dikes To -2 CRP And Add 16 New Chevrons At +2 CRP. Alternative 4 involved the degradation of alternating dikes to -2 CRP along the left descending bank in addition to 16 New Chevrons placed in the same configuration as Alternative 2. Results (Plates 26, 27, and 28) indicated the following trends:

U.S. ARMY ENGINEER DIVISION, NORTHWESTERN CORPS OF ENGINEERS OMAHA, NEBRASKA
	SEDIMENTATION STUDY - MICRO MODEL STUDY MISSOURI RIVER COPELAND BEND RIVER MILES 569 TO 564.5 ALTERNATIVE 4 DIFFERENCE MAP

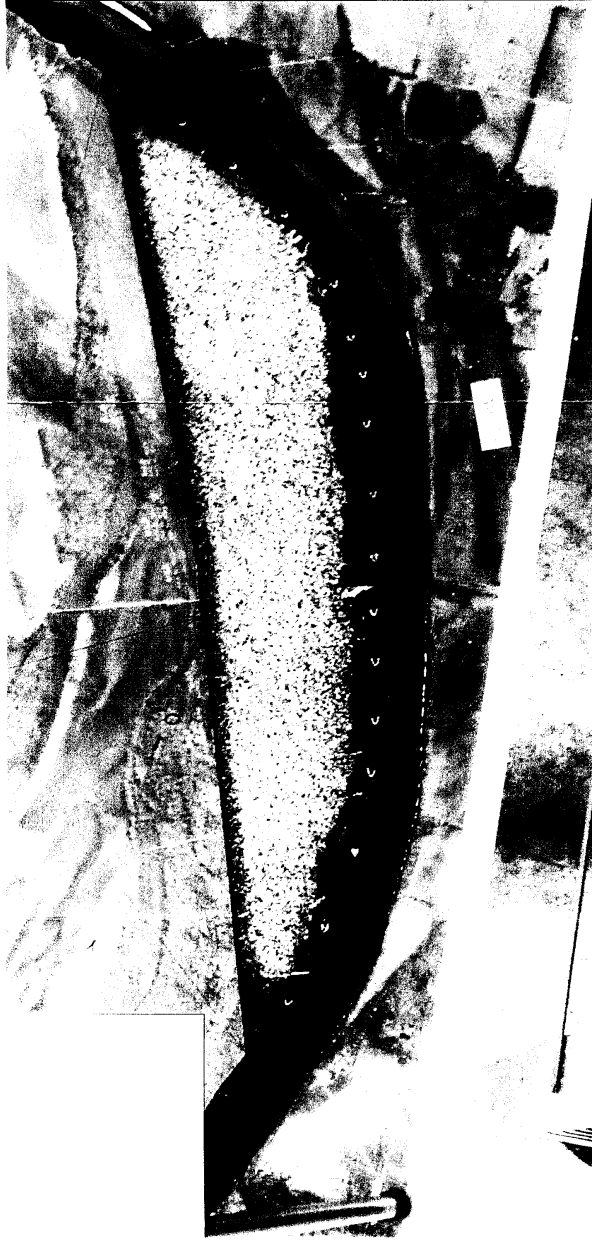
28

Flow visualization showed that flow distribution through the main channel was similar to the base test. Flow still had a tendency to be concentrated at the apex of the bend at Mile 566.0. Results also indicated that more flow was distributed over the dike fields as compared to the base test. In addition, some of the chevrons produced flow "shadows" directly downstream of each structure as a result of individual boundary effects, similar to what was observed in the previous Alternative 2.

Degrade Alternating Dikes to -2 CRP. Chevrons at +2 CRP

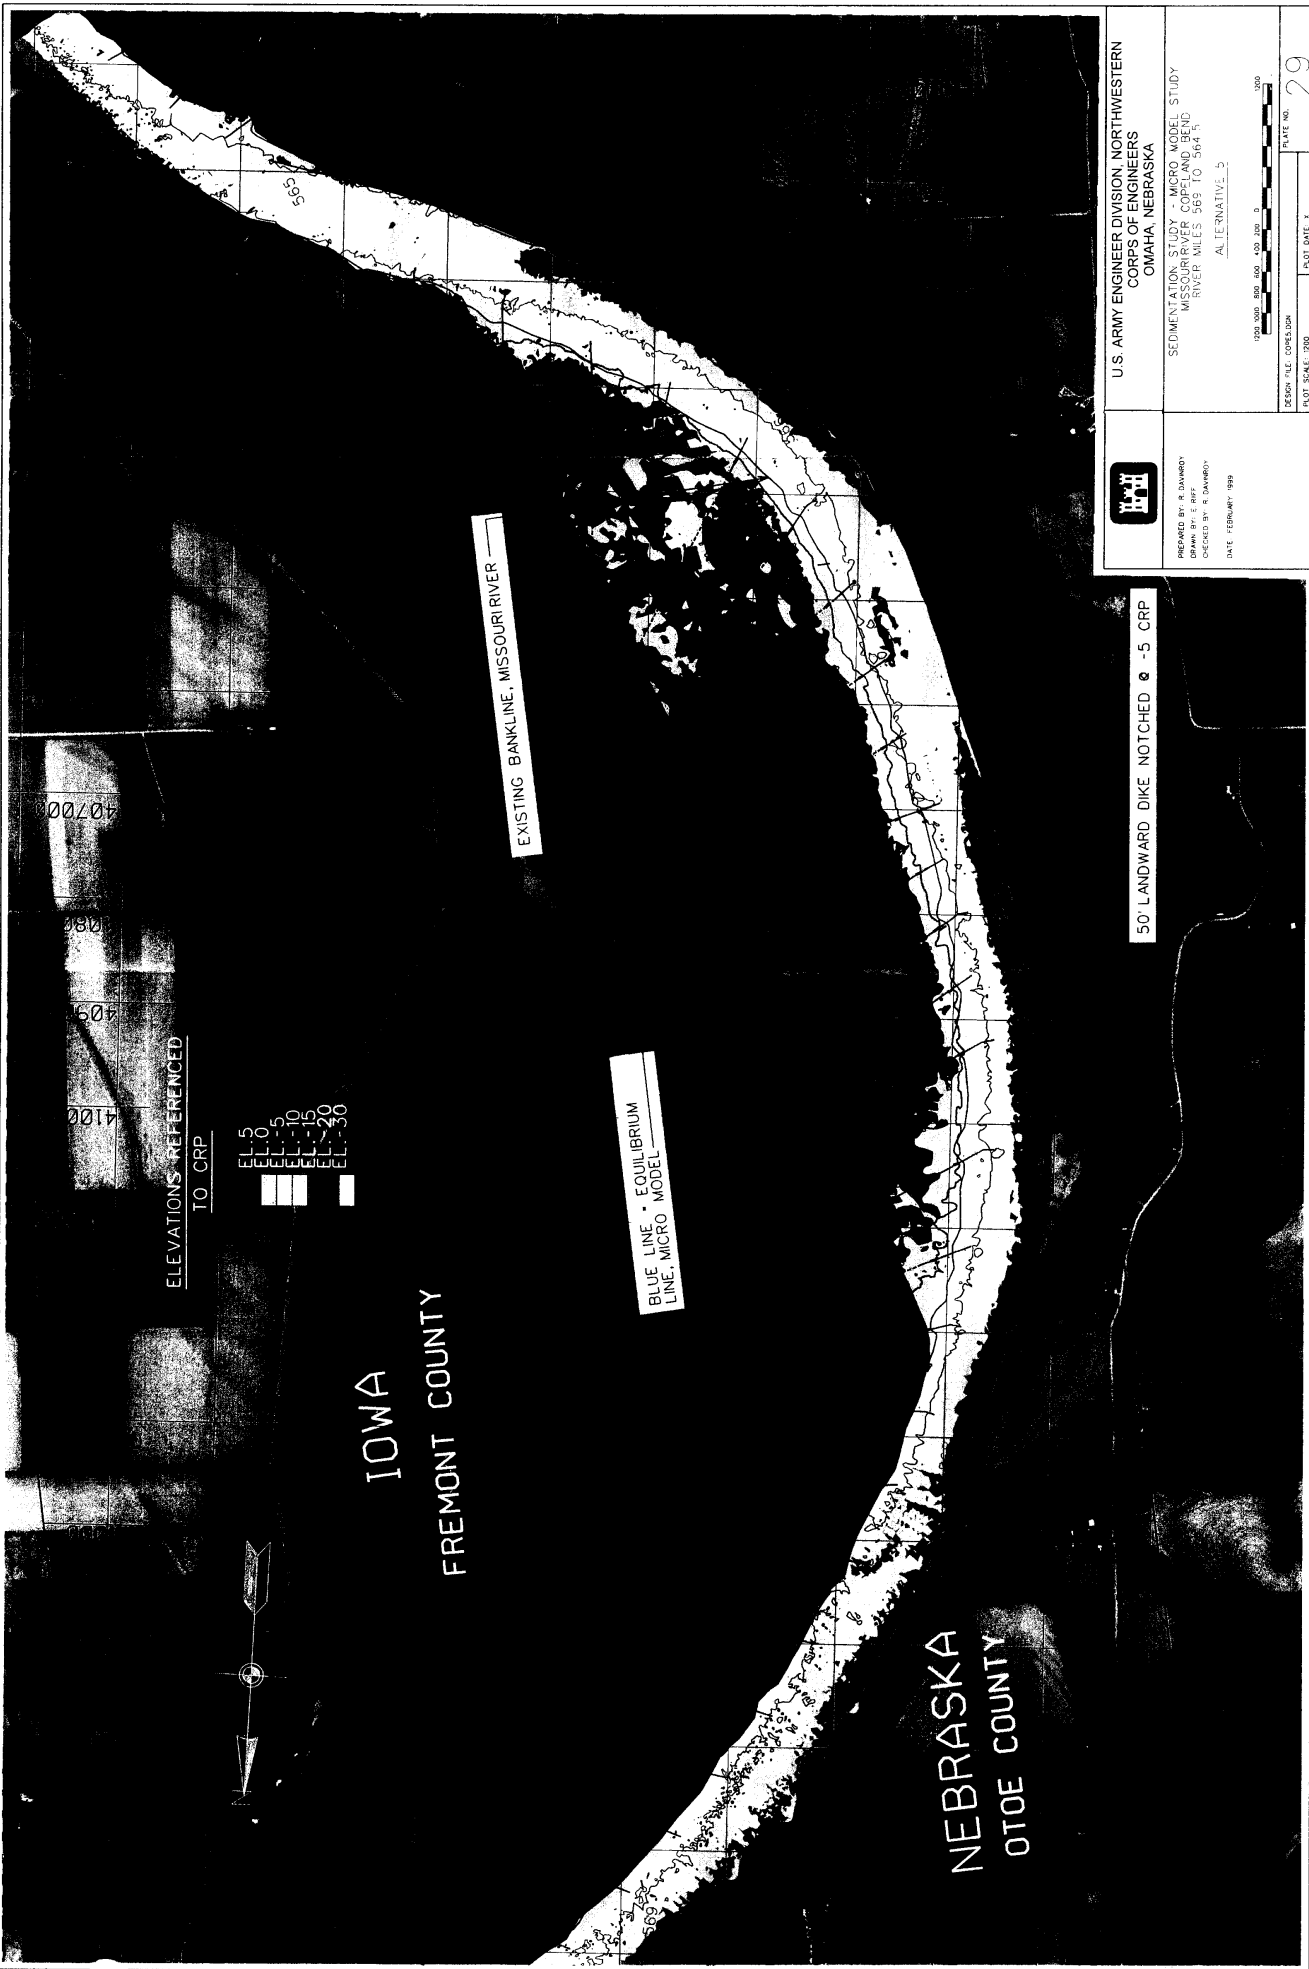
U.S. ARMY ENGINEER DIVISION, NORTHWESTERN CORPS OF ENGINEERS OMAHA, NEBRASKA	
	SEDIMENTATION STUDY - MICRO MODEL STUDY MISSOURI RIVER COPELAND BEND RIVER MILES 565 TO 564.5 ALTERNATIVE 5	
DESIGNED BY: S. DAWSON DRAWN BY: S. DAWSON CHECKED BY: S. DAWSON DATE: FEBRUARY 1999	DESIGN FILE: CORP. 50A NOT SCALE: 1000	PLATE NO. 29

Alternative 5. All Dikes Notched To -5 CRP. Alternative 5 involved excavating a 50-ft landward notch of all existing dikes between Miles 567.8 and 565.3. Results (Plates 29, 30, and 31) indicated the following trends:

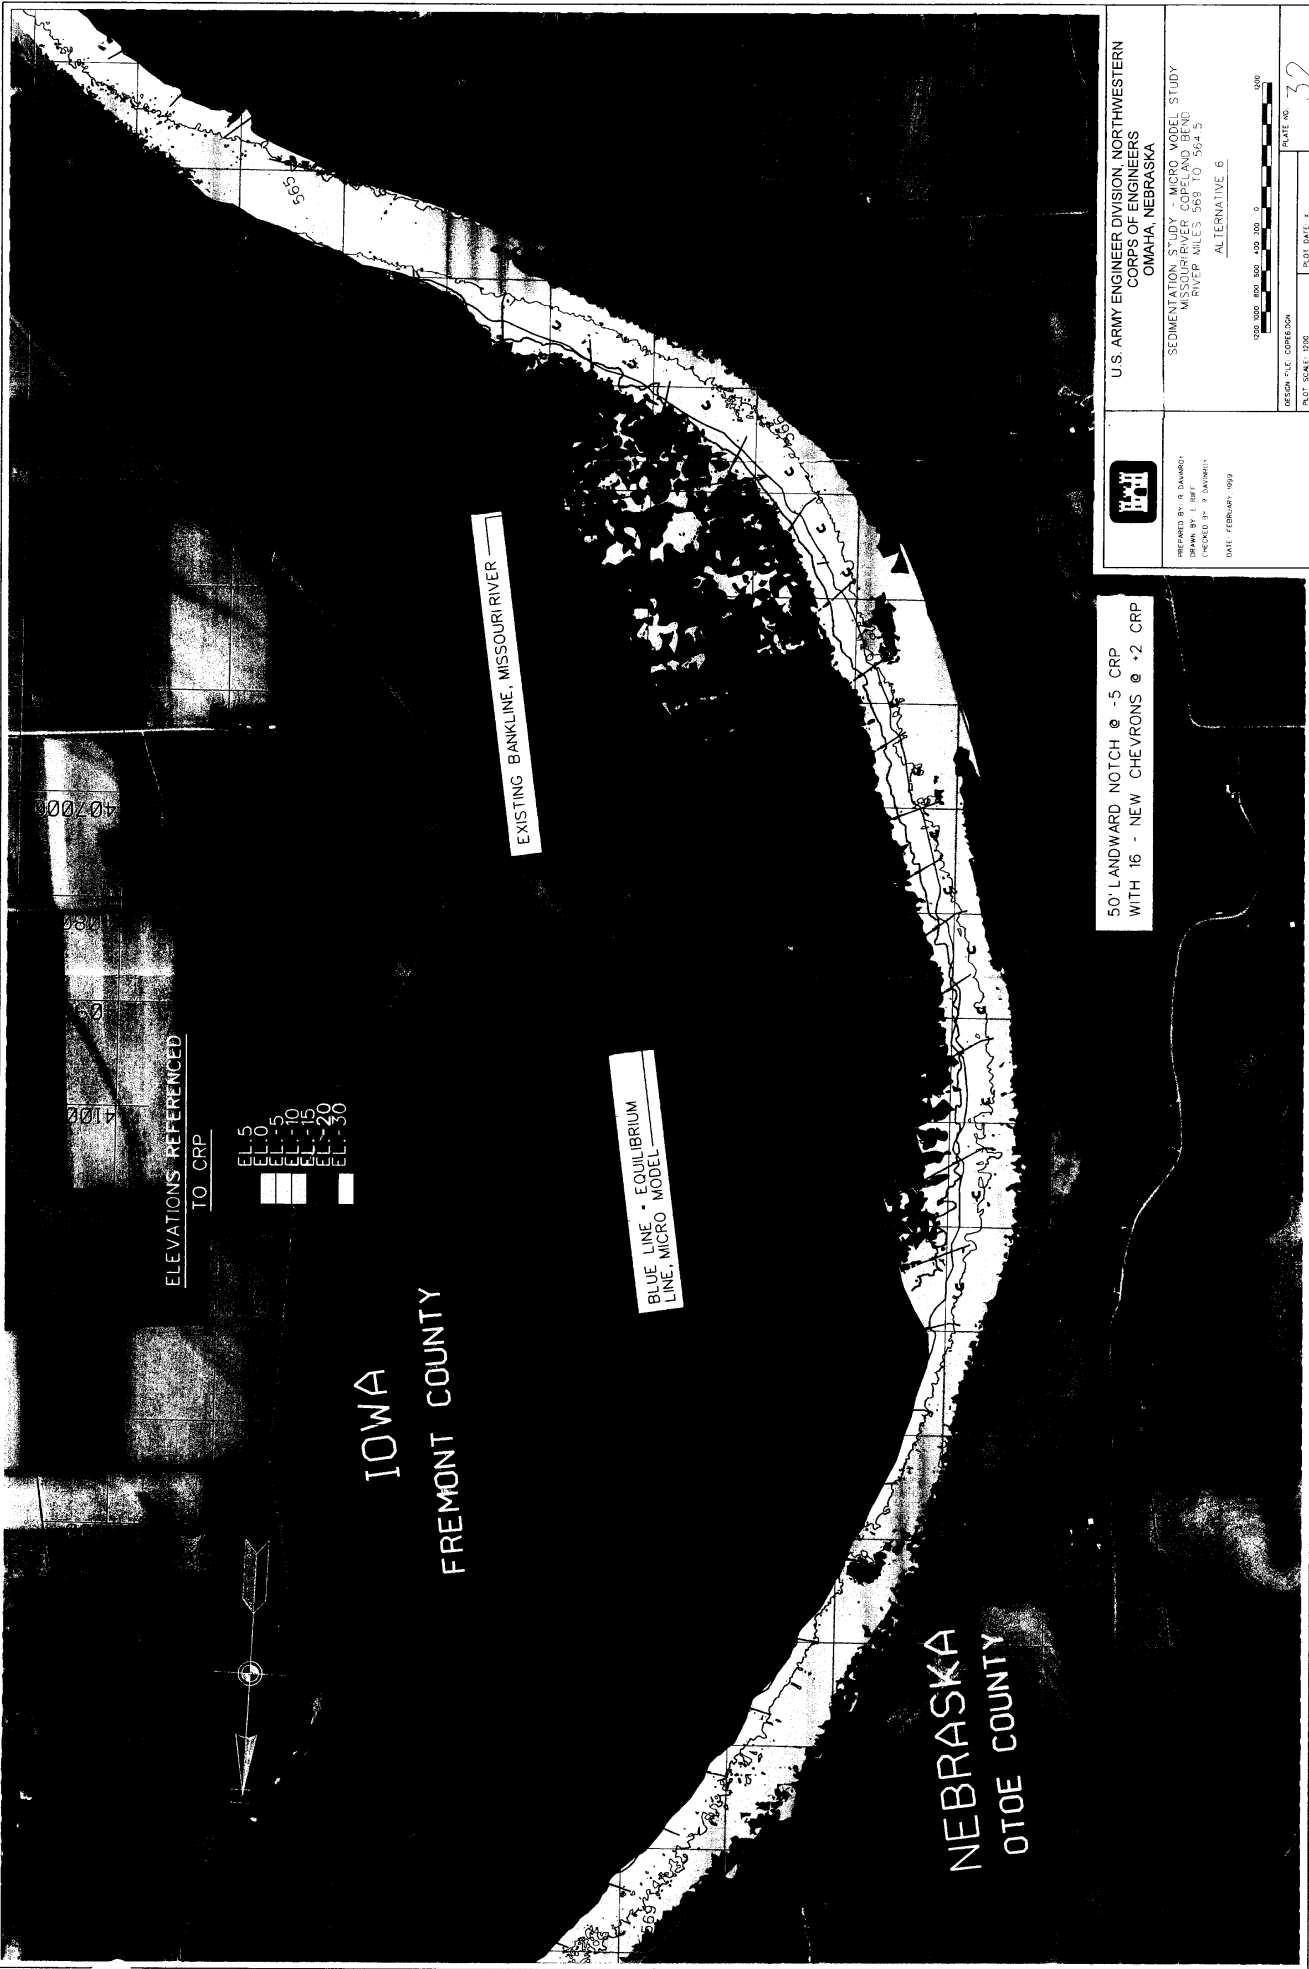
32

50' LANDWARD NOTCH @ -5 CRP
WITH 16 - NEW CHEVRONS @ +2 CRP

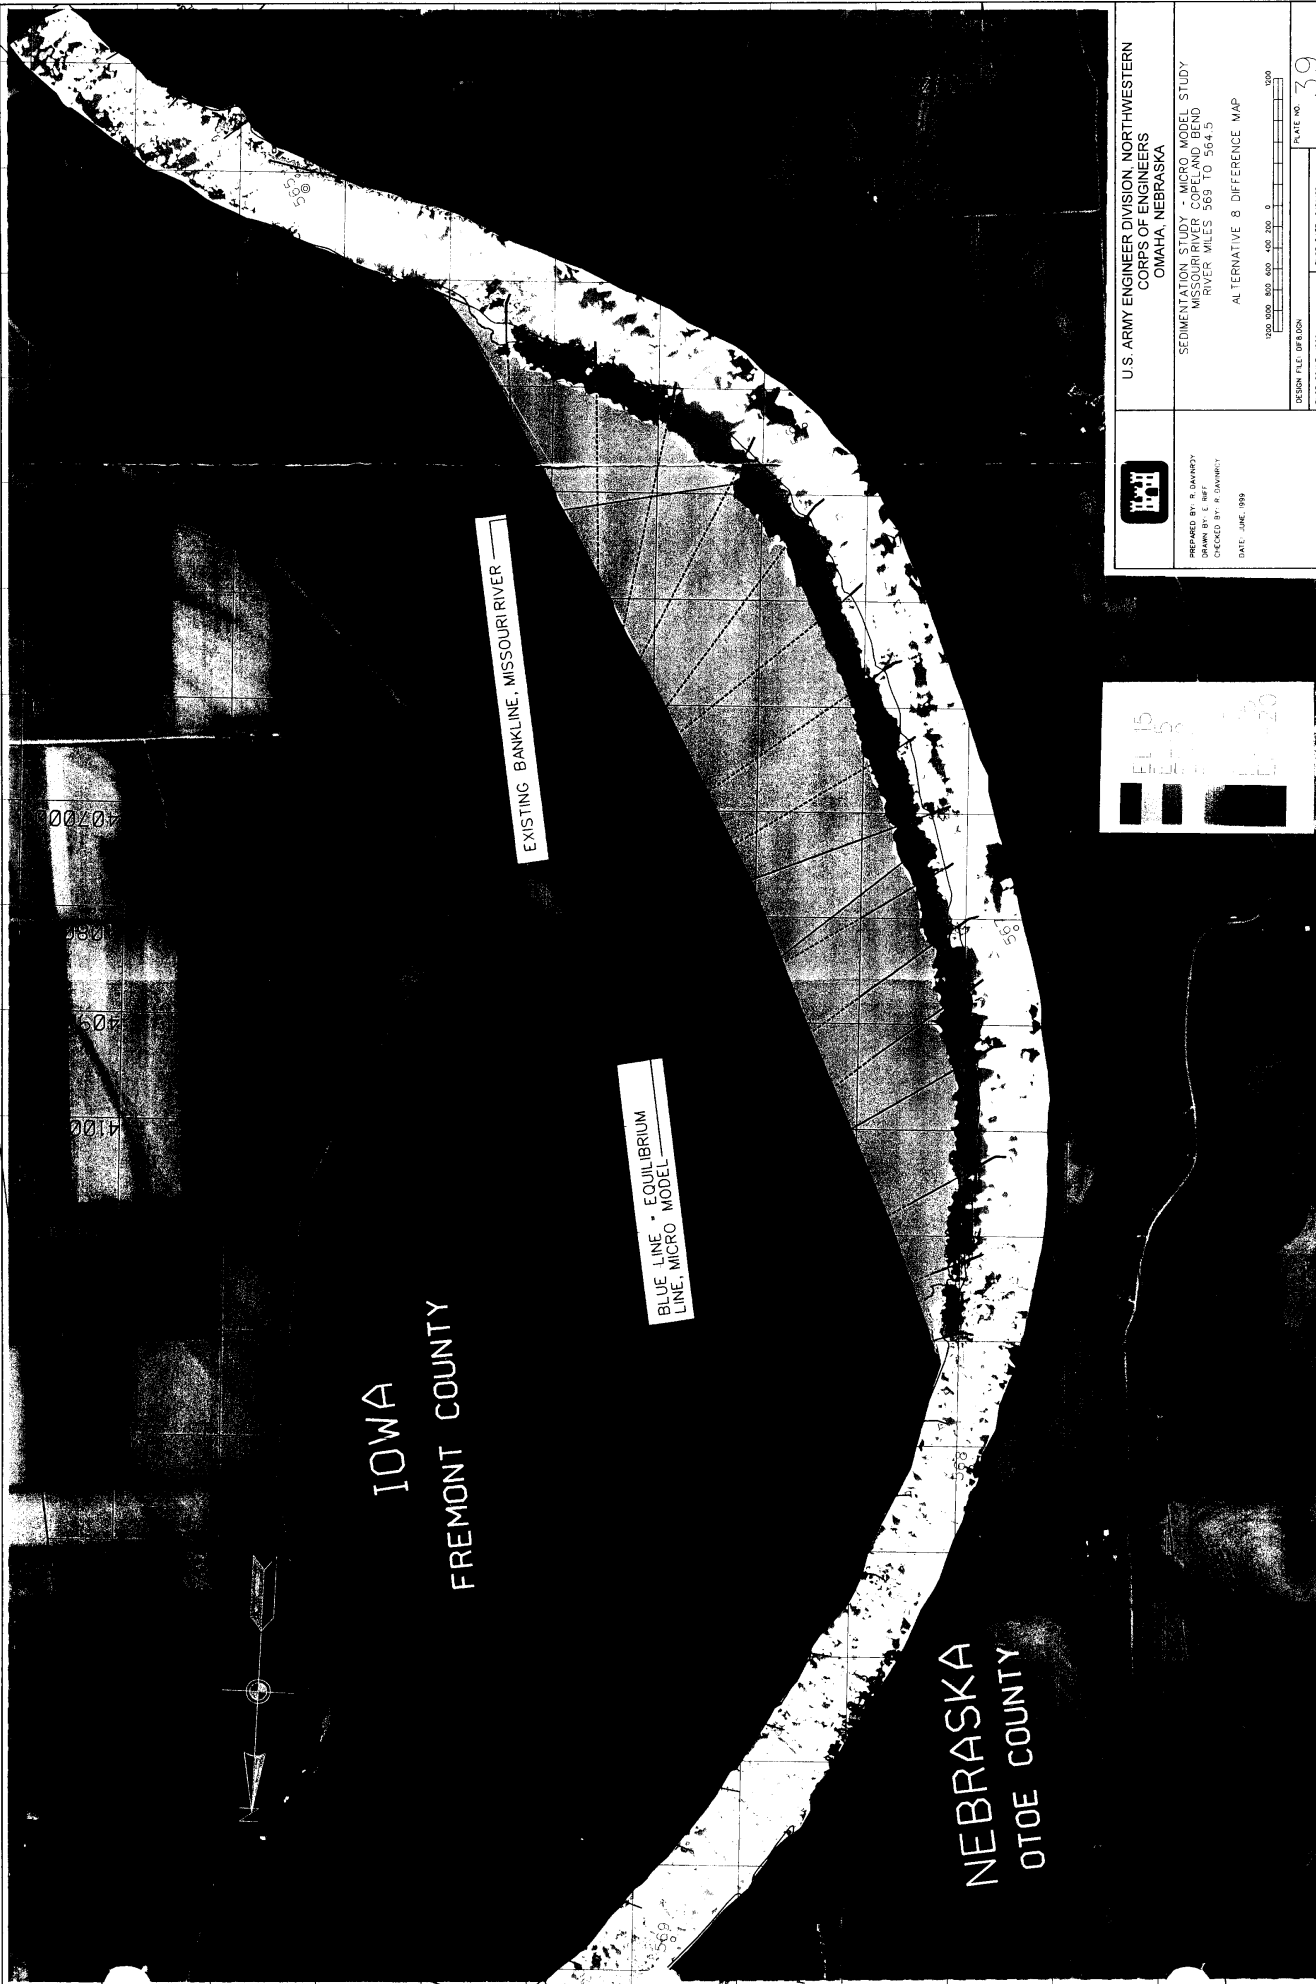
PLATE NO. 38

BANKLINE DEGRADATION TEST WITH DIKES

Alternative 8 involved degrading the left descending bankline between 0 and 400 feet, or approximately 300 feet on the average landward from the base test equilibrium line, to a depth of approximately -10 CRP. Results (Plates 38, 39, 40) indicated the following:
